**Rock Creek Watershed
Feasibility Study**

**Appendix C-1
Proposed Stream
Restoration Projects**

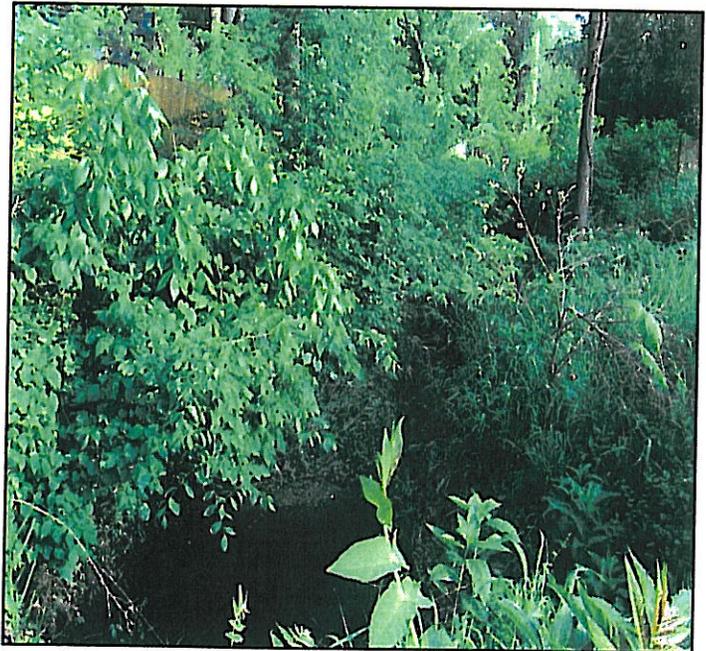
Project 23

Issues:

- Some signs of instability and erosion on both banks.
- Significant sediment deposition of silts, limiting soil gradation.

Optimal Restoration: \$43,214

- Add meandering pattern to channel
- Vegetate banks and create buffer zone
- Provide rip rap/bank protection of channel

Limited Restoration: \$27,675

- Limited vegetation of banks
- Provide rip rap/bank protection of channel

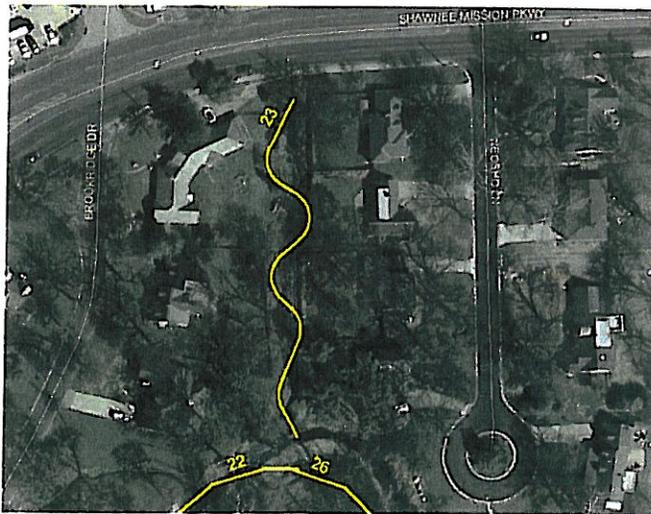
Project 23

The existing length of this reach (Reach ID 16) is 308 feet, and its 2-year flow is 100 cfs. The low cost of restoring this reach produced a high priority rank.

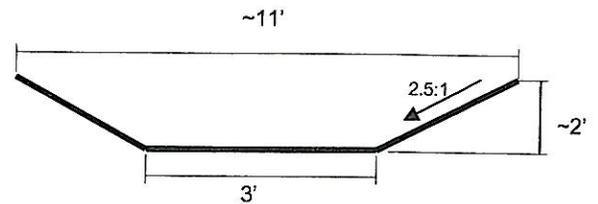
Recommended Cross Section

Recommended Channel Shape

Parameter	Value (ft)
Main Channel Width (w)	11
Wave Length (L)	126
Pool-riffle Spacing	63
Radius of Curvature (Rc)	27
Range*	22-56
Amplitude (Amp)	20

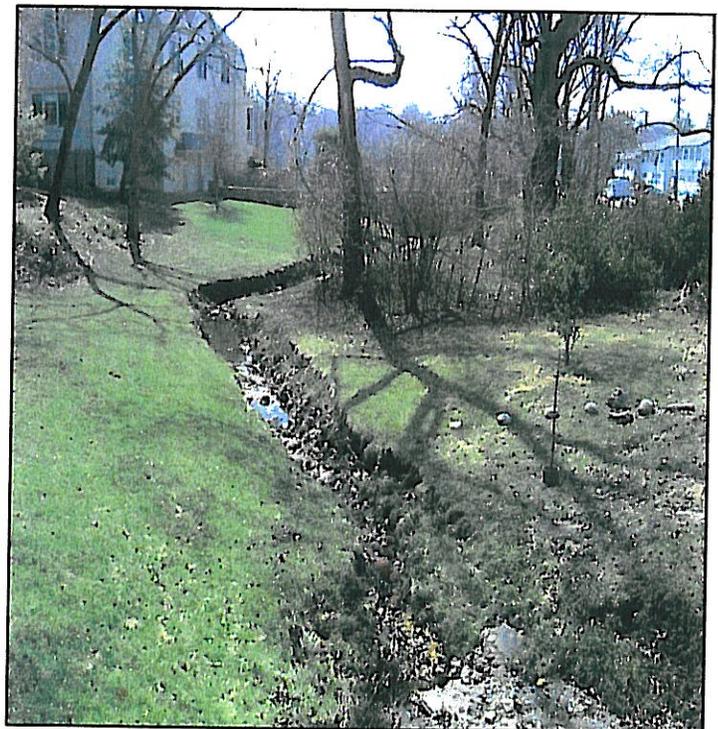
Project 24

Issues:

- Significant down-cutting, instability and erosion
- Lack of native vegetation and stream corridor.

Optimal Restoration:

- Add meandering pattern to channel
- Vegetate banks and create buffer zone
- Provide rip rap/bank protection of channel as necessary

Limited Restoration:

- Limited vegetation of banks
- Provide rip rap/bank protection of channel as necessary

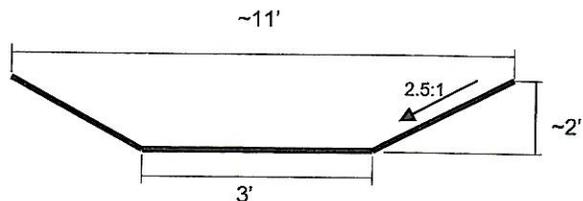
Recommended Cross Section

Recommended Channel Shape

Parameter	Value (ft)
Main Channel Width (w)	11
Wave Length (L)	126
Pool-riffle Spacing	63
Radius of Curvature (Rc)	27
Range*	22-56
Amplitude (Amp)	20

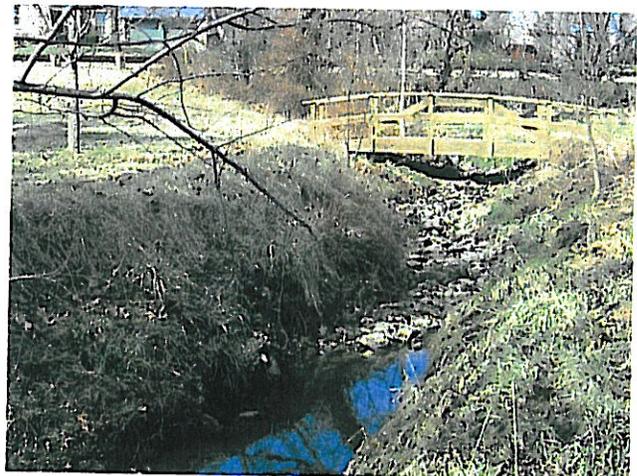
Project 36 44

Issues:

- Some signs of instability and erosion on both banks

Optimal Restoration:

- Add meandering pattern to channel
- Vegetate banks and create buffer zone
- Provide rip rap/bank protection of channel

Limited Restoration:

- Limited vegetation of banks
- Provide rip rap/bank protection of channel

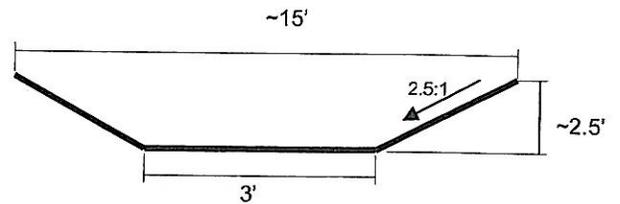
Recommended Cross Section

Recommended Channel Shape

Parameter	Value (ft)
Main Channel Width (w)	15
Wave Length (L)	167
Pool-riffle Spacing	83
Radius of Curvature (Rc)	36
Range*	30-74
Amplitude (Amp)	27

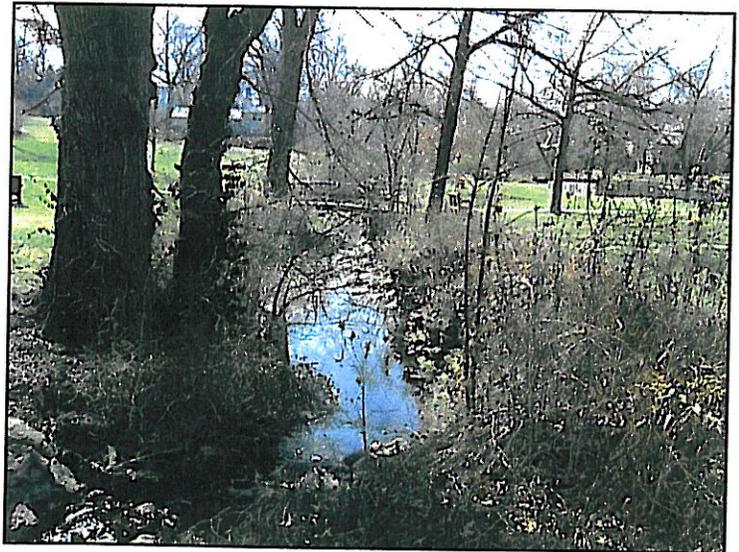
Project 30 Inlet Missing NE section w/ Roaded Bank

Issues:

- Some signs of instability and erosion on both banks
- Lack of vegetated stream corridor

Optimal Restoration:

- Develop stable cross section
- Vegetate banks and create buffer zone
- Provide rip rap/bank protection of channel

Limited Restoration:

- Limited vegetation of banks
- Provide rip rap/bank protection of channel

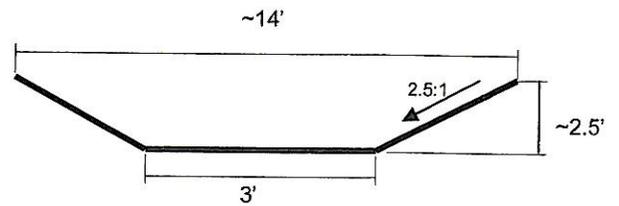
Recommended Cross Section

Recommended Channel Shape

Parameter	Value (ft)
Main Channel Width (w)	14
Wave Length (L)	154
Pool-riffle Spacing	77
Radius of Curvature (Rc)	33
Range*	27-69
Amplitude (Amp)	25

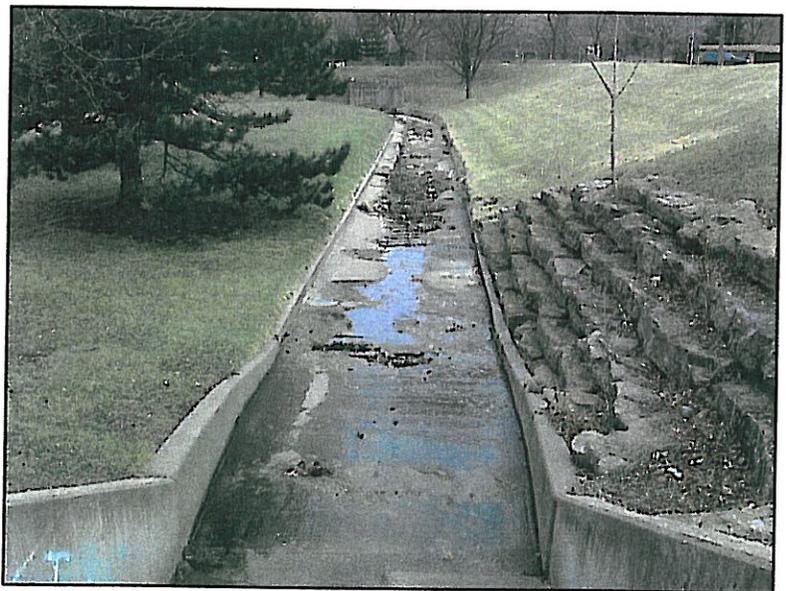
Project 18

Issues:

- Existing channel experiencing degradation.
- Concrete channels provide little habitat or water quality value, increase flow velocities and possibly contribute to downstream flooding concerns.

Optimal Restoration:

- Add meandering pattern to channel
- Replace concrete channel with stable cross section.
- Vegetate banks and create buffer zone
- Provide rip rap/bank protection of channel

Limited Restoration:

- Replace concrete channel with stable cross section
- Limited vegetation of banks
- Provide rip rap/bank protection of channel

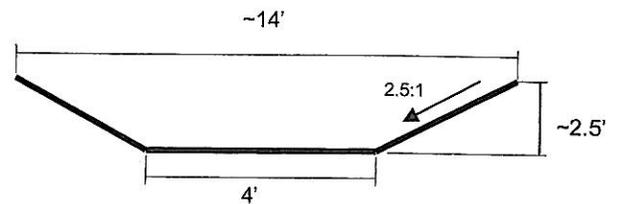
Recommended Cross Section

Recommended Channel Shape

Parameter	Value (ft)
Main Channel Width (w)	14
Wave Length (L)	158
Pool-riffle Spacing	79
Radius of Curvature (Rc)	34
Range*	28-70
Amplitude (Amp)	25

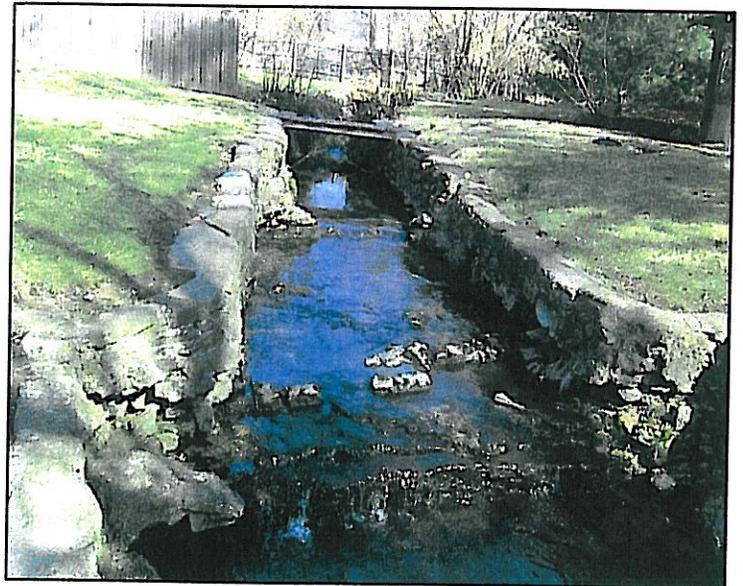
Project 29 – Segment 1

Issues:

- Channel infrastructure degrading
- Lack of stream buffer between lawns and tributary

Optimal Restoration:

- Add meandering pattern to channel
- Develop stable cross section
- Vegetate banks and create buffer zone
- Provide rip rap/bank protection of channel

Limited Restoration:

- Limited vegetation of banks
- Provide rip rap/bank protection of channel

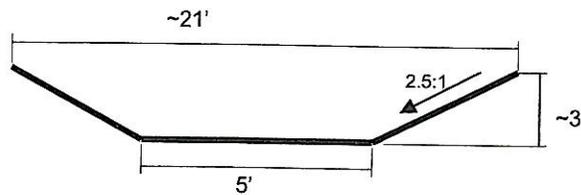
Recommended Cross Section

Recommended Channel Shape

Parameter	Value (ft)
Main Channel Width (w)	21
Wave Length (L)	235
Pool-riffle Spacing	117
Radius of Curvature (Rc)	50
Range*	42-104
Amplitude (Amp)	38

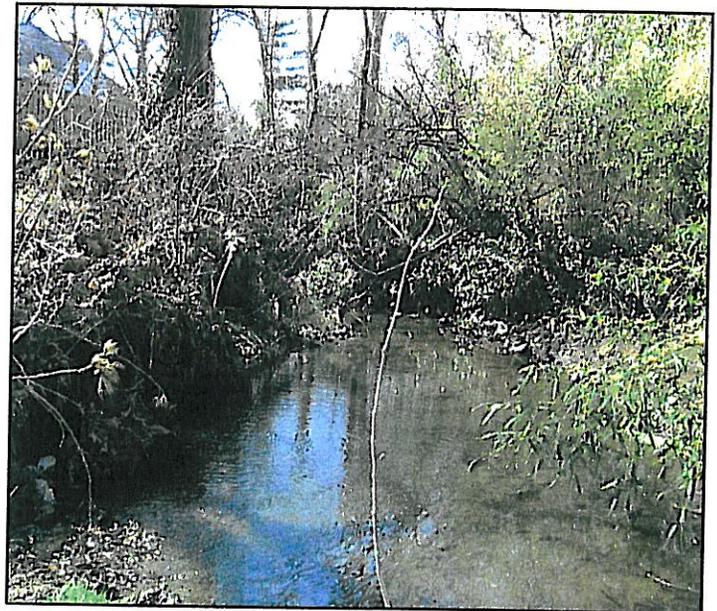
Project 29 – Segment 2

Issues:

- Observed instability and erosion on both banks

Optimal Restoration:

- Add meandering pattern to channel
- Develop stable cross section
- Vegetate banks and create buffer zone
- Provide rip rap/bank protection of channel

Limited Restoration:

- Develop stable cross section
- Limited vegetation of banks
- Provide rip rap/bank protection of channel

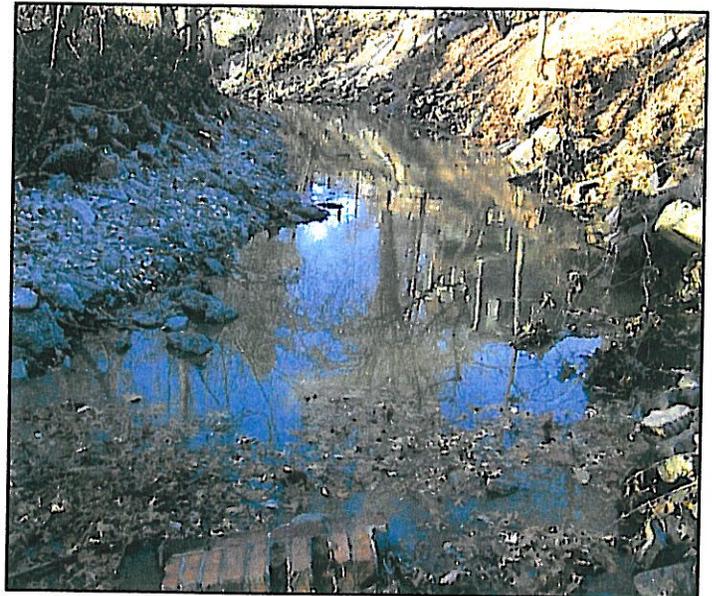
Project 26

Issues:

- Instability and erosion in key areas along project length as stream is naturally attempting to transition into a stable form.
- Lack of consistent stream buffer between creek and neighborhood lawns.

Optimal Restoration:

- Add meandering pattern to channel where applicable
- Vegetate banks and create buffer zone
- Provide rip rap/bank protection of channel where necessary

Limited Restoration:

- Limited vegetation of banks
- Provide rip rap/bank protection of channel

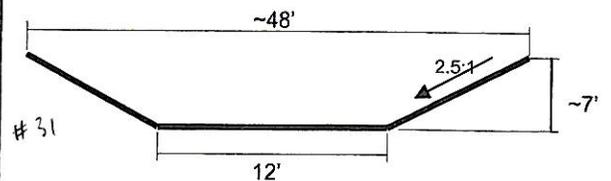
Recommended Cross Section

Recommended Channel Shape

Parameter	Value (ft)
Main Channel Width (w)	48
Wave Length (L)	543 - Meanders
Pool-riffle Spacing	272 - distance between - AVG
Radius of Curvature (Rc)	116
Range*	96-241 96 tight
Amplitude (Amp)	87 - how far out from straight line from tip to tip

deep section (pointing to Wave Length)
rocks (pointing to Radius of Curvature)
Energy dissipation (pointing to Pool-riffle Spacing)

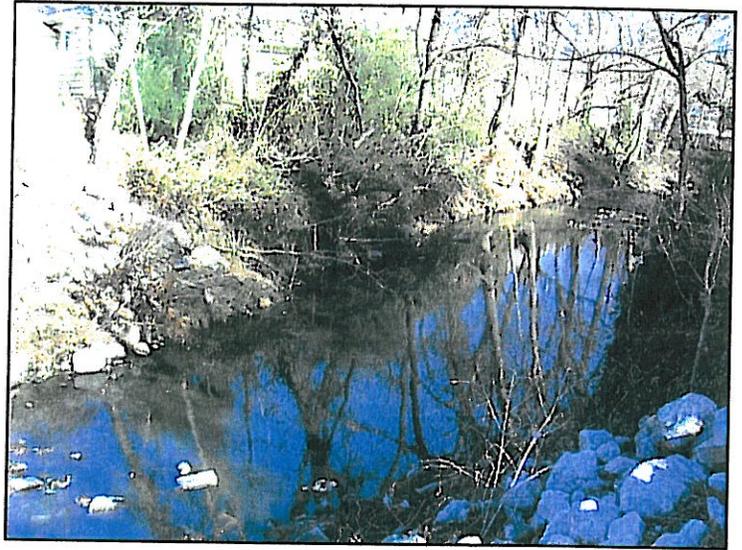
Project 27 – Segment 1

Issues:

- Evidence of erosion and instability
- Lack of native vegetation and stream buffer

Optimal Restoration:

- Add meandering pattern to channel
- Develop stable cross section with natural slopes and benching
- Provide rip rap/bank protection of channel

Limited Restoration:

- Develop stable cross section with natural slopes and benching
- Provide rip rap/bank protection of channel

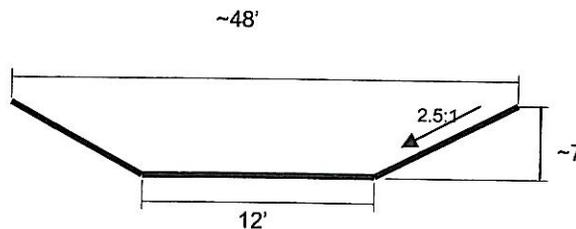
Recommended Cross Section

Recommended Channel Shape

Parameter	Value (ft)
Main Channel Width (w)	48
Wave Length (L)	543
Pool-riffle Spacing	272
Radius of Curvature (Rc)	116
Range*	96-241
Amplitude (Amp)	87

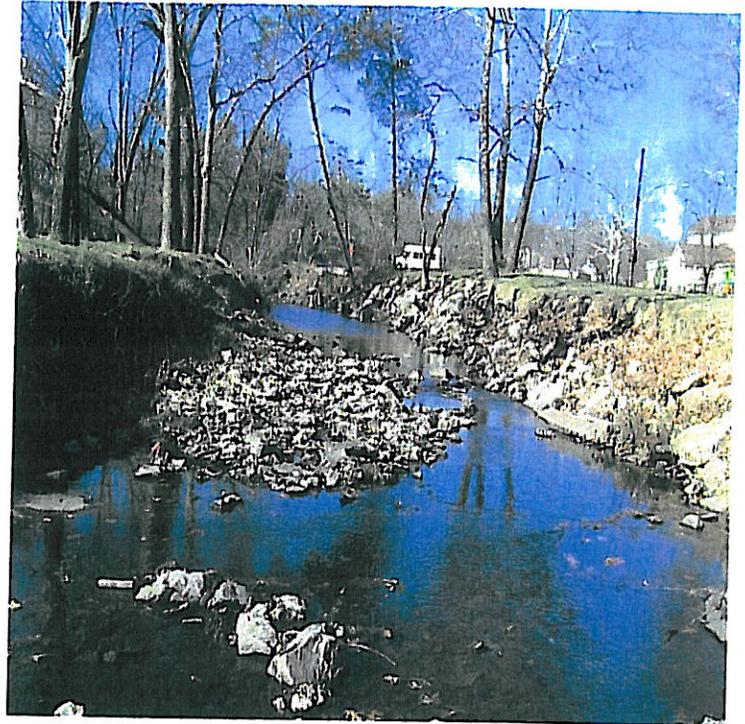
Project 27 – Segment 2

Issues:

- Some signs of instability and erosion on both banks
- Lack of stream buffer between lawns, parking lots and creek

Optimal Restoration:

- Add meandering pattern to channel
- Vegetate banks and create buffer zone
- Provide rip rap/bank protection of channel

Limited Restoration:

- Limited vegetation of banks
- Provide rip rap/bank protection of channel

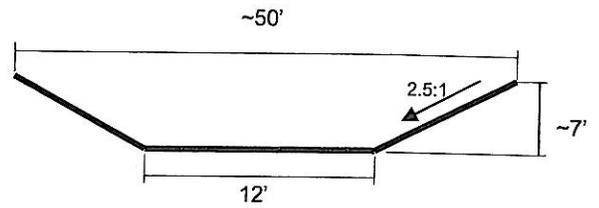
Recommended Cross Section

Recommended Channel Shape

Parameter	Value (ft)
Main Channel Width (w)	50
Wave Length (L)	564
Pool-riffle Spacing	282
Radius of Curvature (Rc)	120
Range*	100-250
Amplitude (Amp)	90

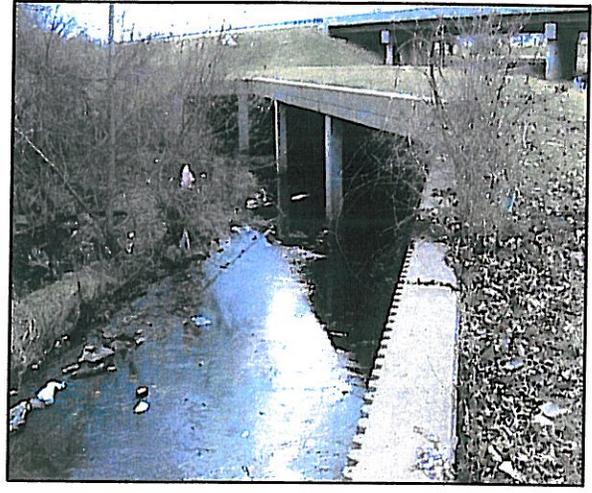
Project 33 – Segment 1

Issues:

- Limited infrastructure is degrading
- Some signs of erosion on both banks
- Concrete channels provide little habitat or water quality value, increase flow velocities and possibly contribute to downstream flooding concerns.

Optimal Restoration:

- Add meandering pattern to channel
- Replace left and right channel wall with sufficient width to develop low flow channel and flood benches.
- Provide rip rap/bank protection of channel

Limited Restoration:

- Replace left and right channel wall with sufficient width to develop low flow channel and flood benches.
- Provide rip rap/bank protection of channel

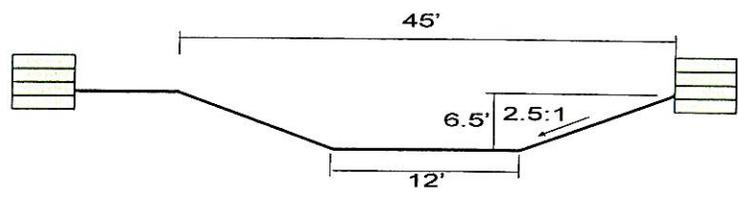
Recommended Cross Section

Recommended Channel Shape

Parameter	Value (ft)
Main Channel Width (w)	45
Wave Length (L)	501
Pool-riffle Spacing	251
Radius of Curvature (Rc)	107
Range*	89-223
Amplitude (Amp)	80

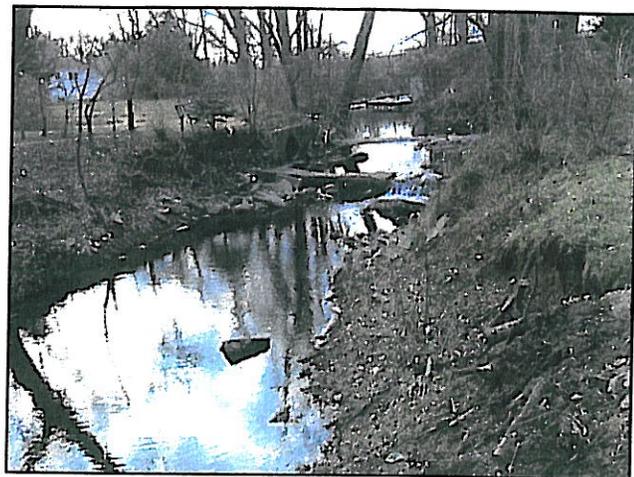
Project 33 – Segment 2

Issues:

- Some signs of instability and erosion on both banks
- Lack of community education of water quality and stream corridors.

Optimal Restoration:

- Add meandering pattern to channel
- Vegetate banks and create buffer zone
- Provide rip rap/bank protection of channel

Limited Restoration:

- Develop stable cross section, providing bank protection
- Limited vegetation of banks

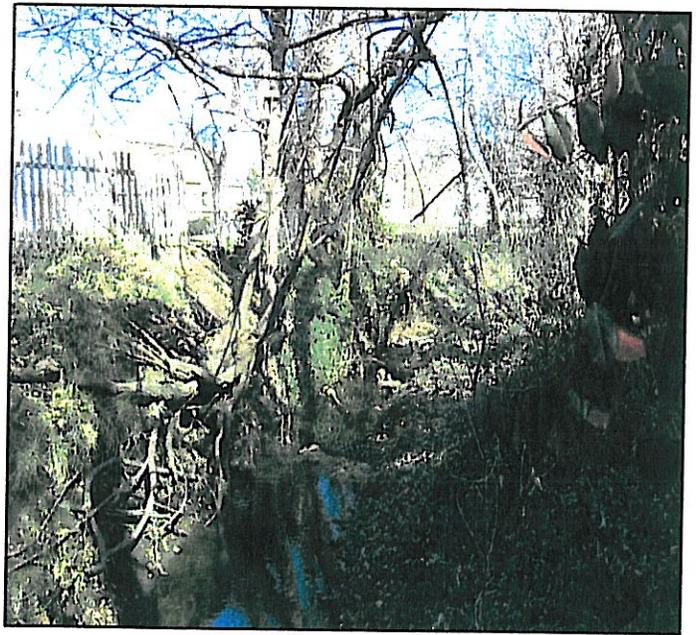
Project 28 Mission Bridge - Greenspace

Issues:

- Some signs of instability and erosion on both banks
- Lack of native vegetation

Optimal Restoration:

- Add channel wall on left and right banks
- Incorporate vegetation and stable cross section
- Provide rip rap/bank protection of channel

Limited Restoration:

- Add channel wall on left bank
- Limited vegetation of both banks
- Provide rip rap/bank protection of channel as necessary

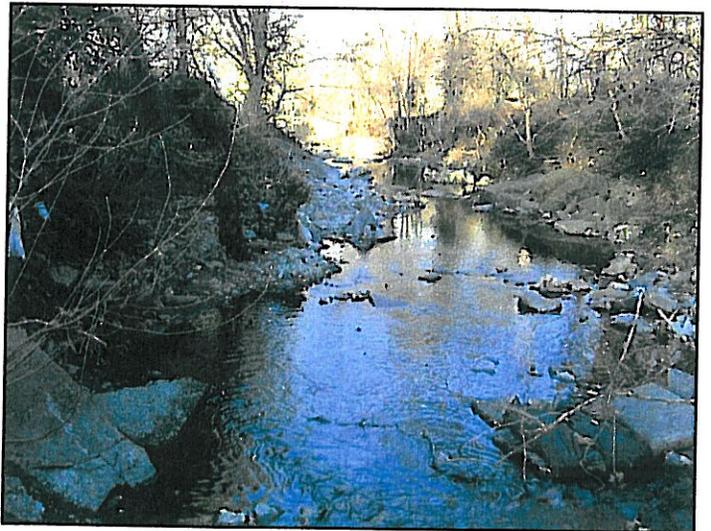
Project 22

Issues:

- Significant erosion and instability on both banks

Optimal Restoration:

- Add meandering pattern to channel
- Integrate recommended stable cross section
- Vegetate banks and create buffer zone
- Provide rip rap/bank protection of channel

Limited Restoration:

- Integrate recommended stable cross section
- Limited vegetation of banks
- Provide rip rap/bank protection of channel as necessary

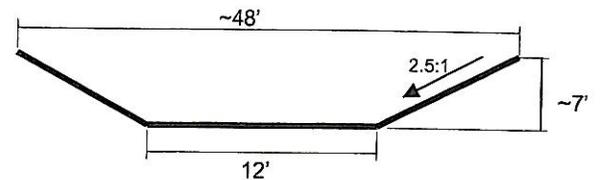
Recommended Cross Section

Recommended Channel Shape

Parameter	Value (ft)
Main Channel Width (w)	48
Wave Length (L)	545
Pool-riffle Spacing	273
Radius of Curvature (Rc)	116
Range*	97-242
Amplitude (Amp)	87
