## DESIGN MEMORANDUM

Subject: Belinder Avenue Traffic Calming Study

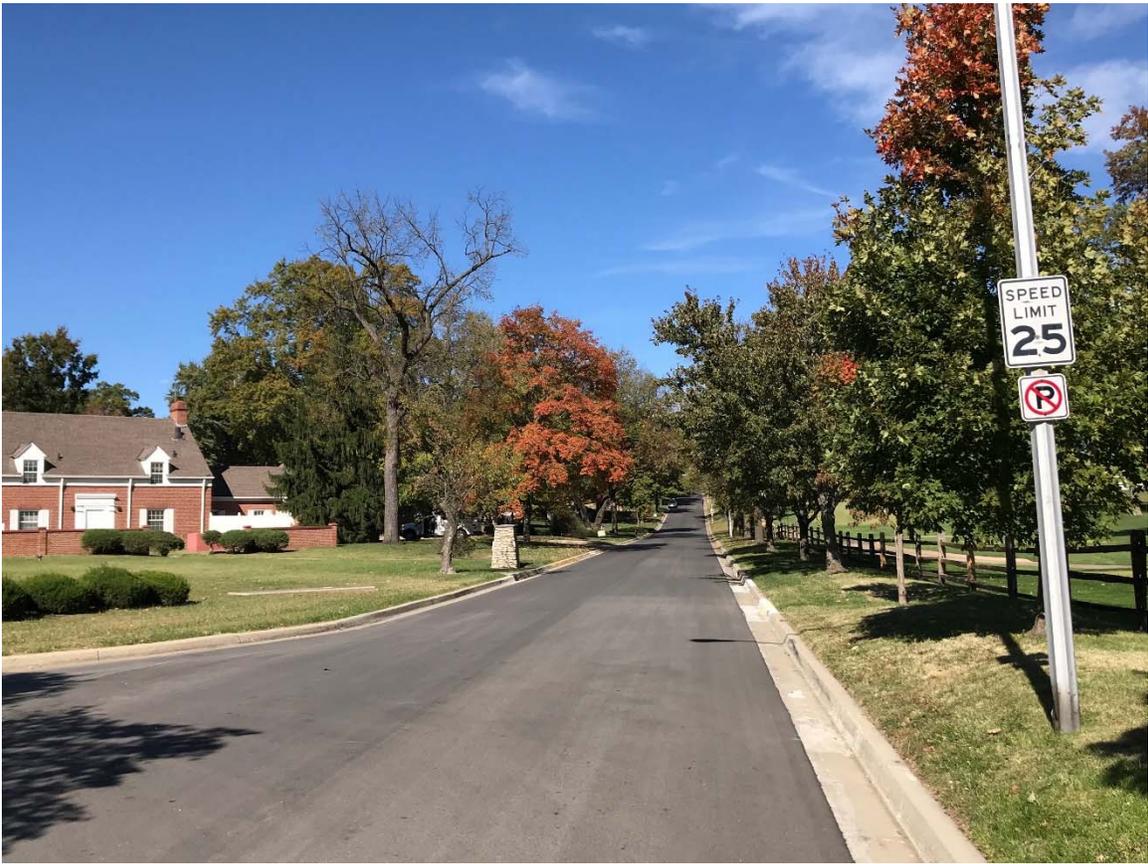
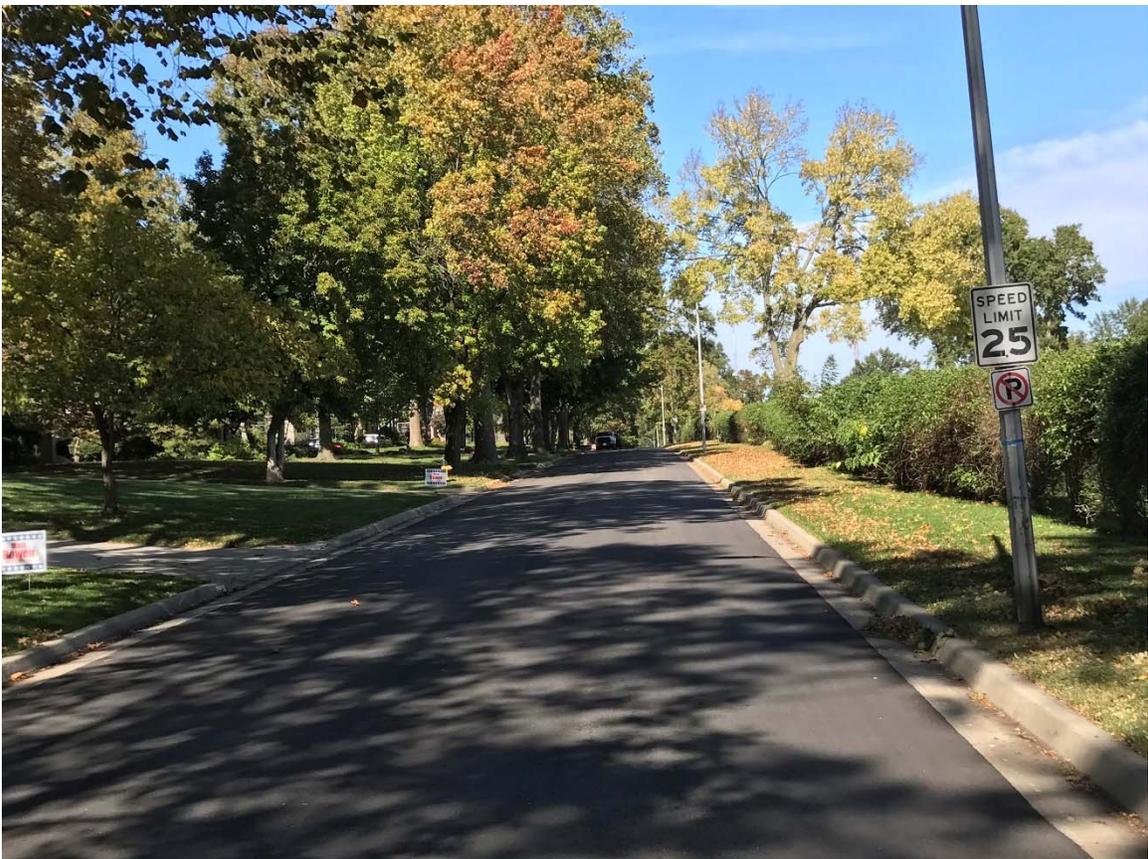
# EXHIBIT A

*Belinder Avenue – South End Looking North*

*Belinder Avenue – Middle Looking North*

On-street parking is allowed in front of the adjacent residences, but is prohibited along the eastern side of the road. The posted speed limit along the study segment of Belinder Avenue is currently 25 miles per hour (mph). At this time, there are no sidewalks or other bicycle / pedestrian accommodations provided along the corridor. The existing conditions along the corridor are generally depicted on the photos provided as ***Exhibits A through D***.

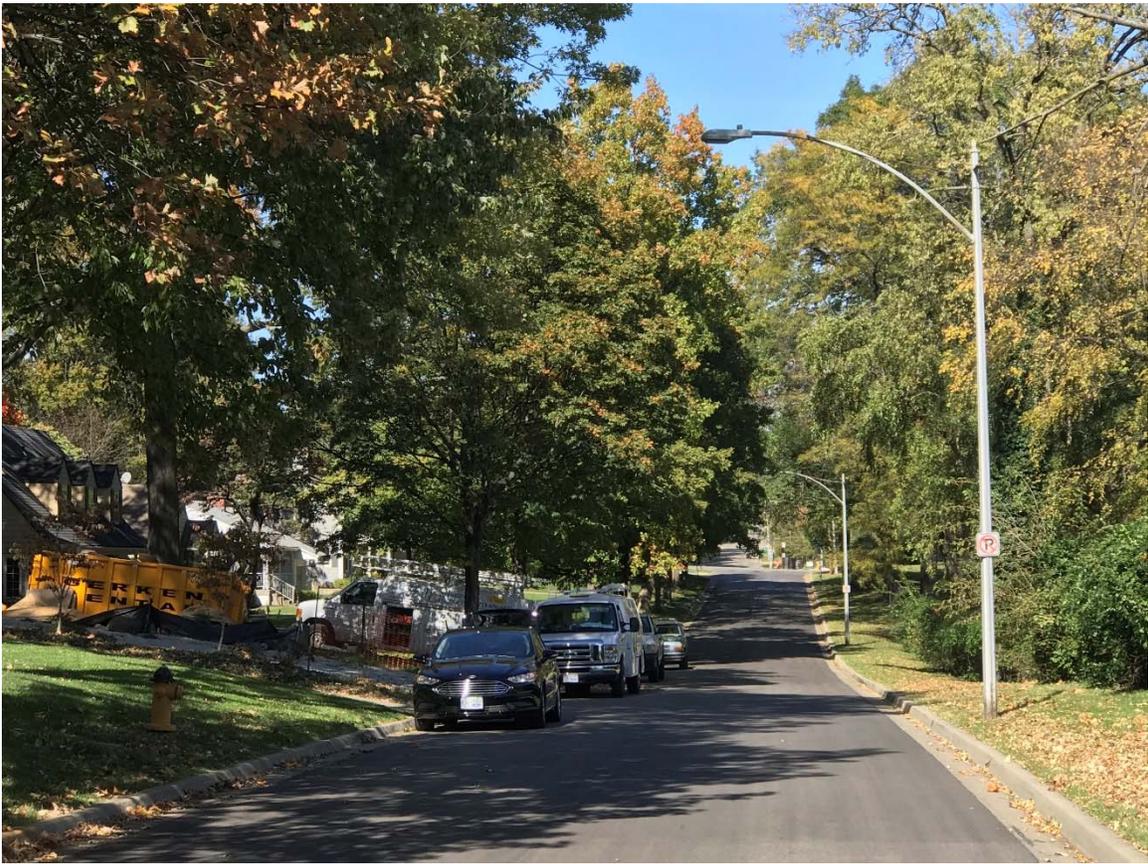
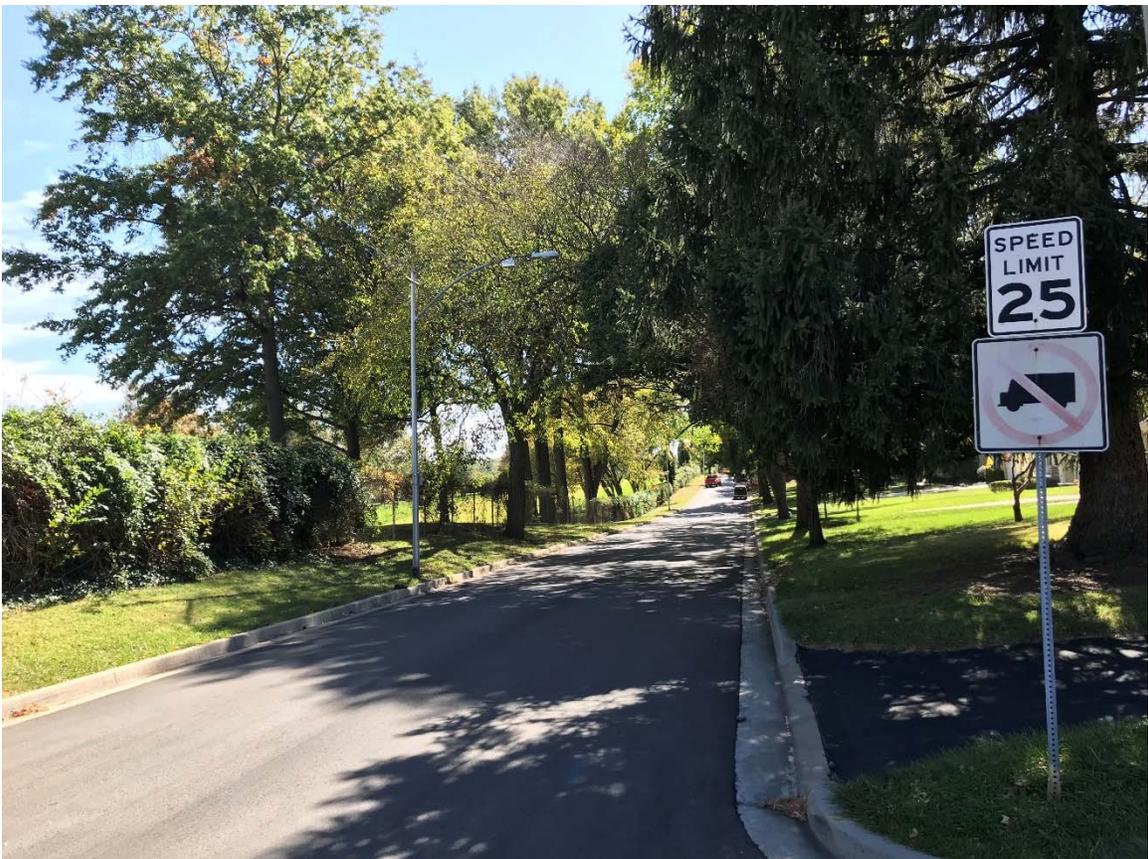
## EXHIBIT B

*Belinder Avenue – North End Looking North*

*Belinder Avenue – North End Looking South*

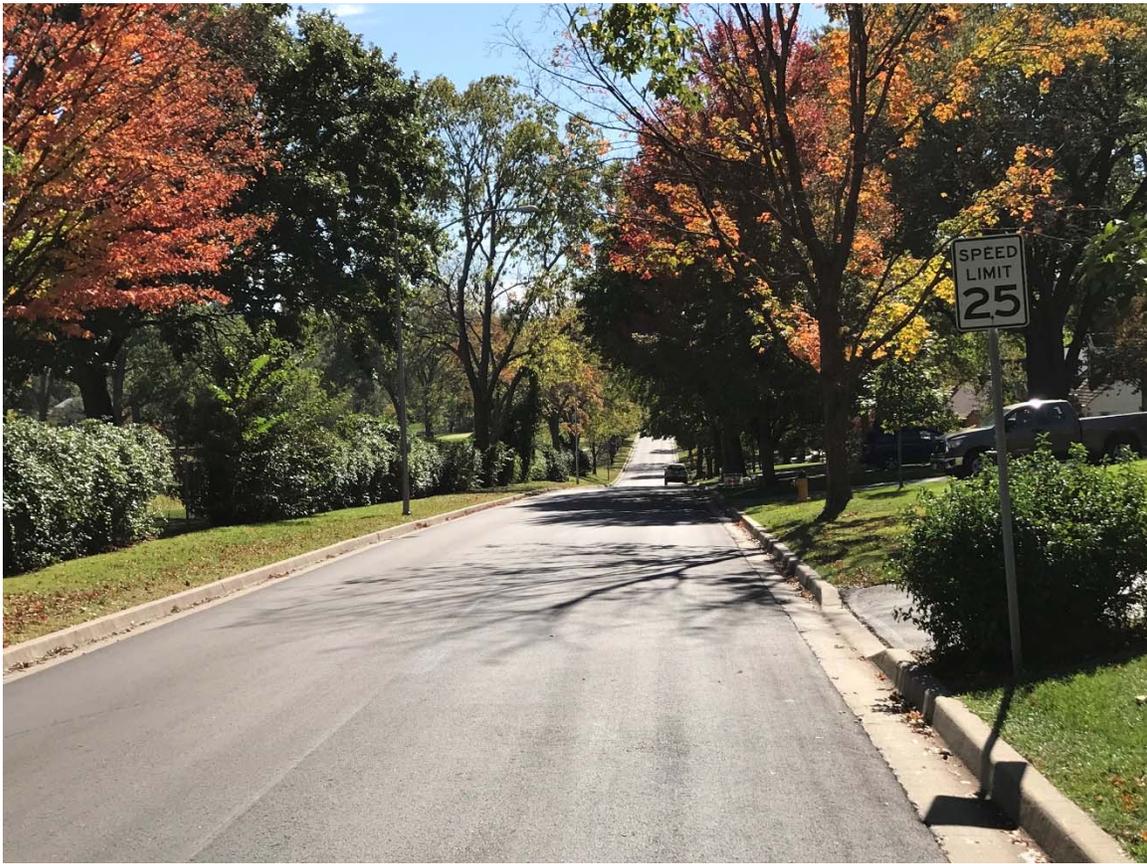
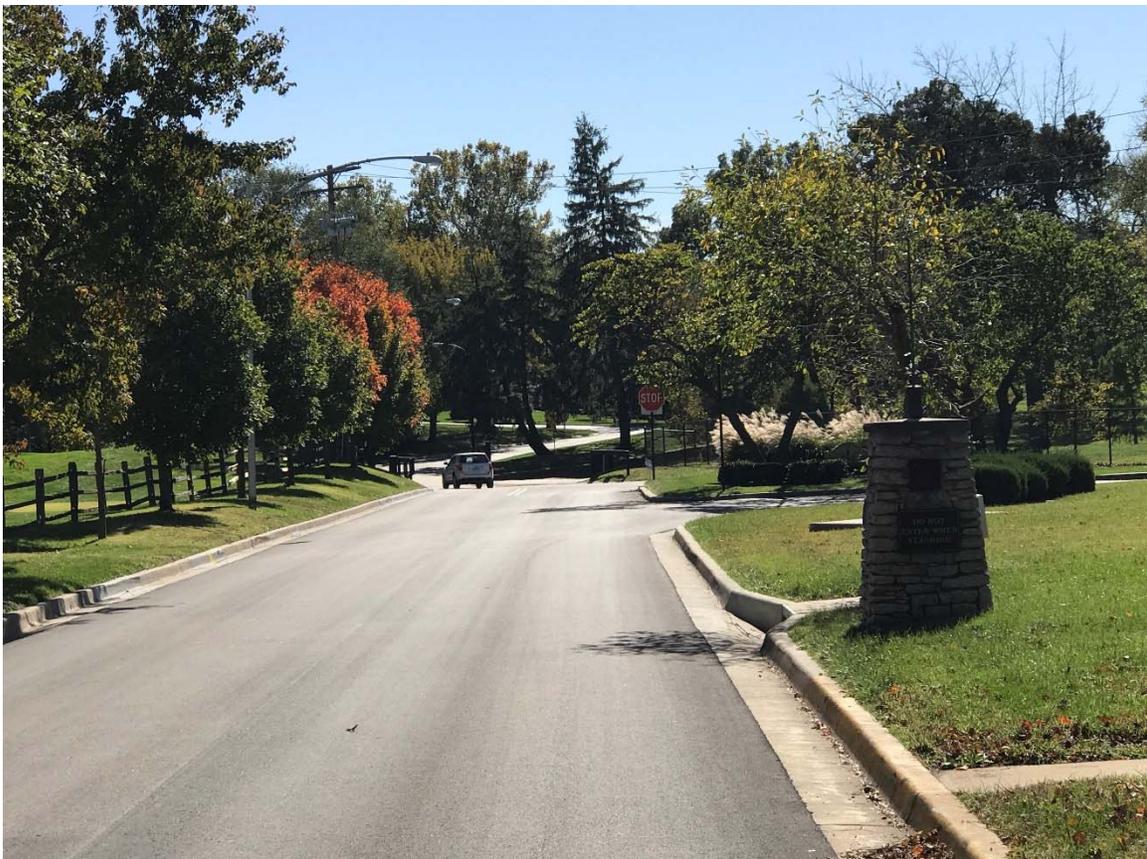
## EXHIBIT C

*Belinder Avenue – Middle Looking South*

*Belinder Avenue – South End Looking South*

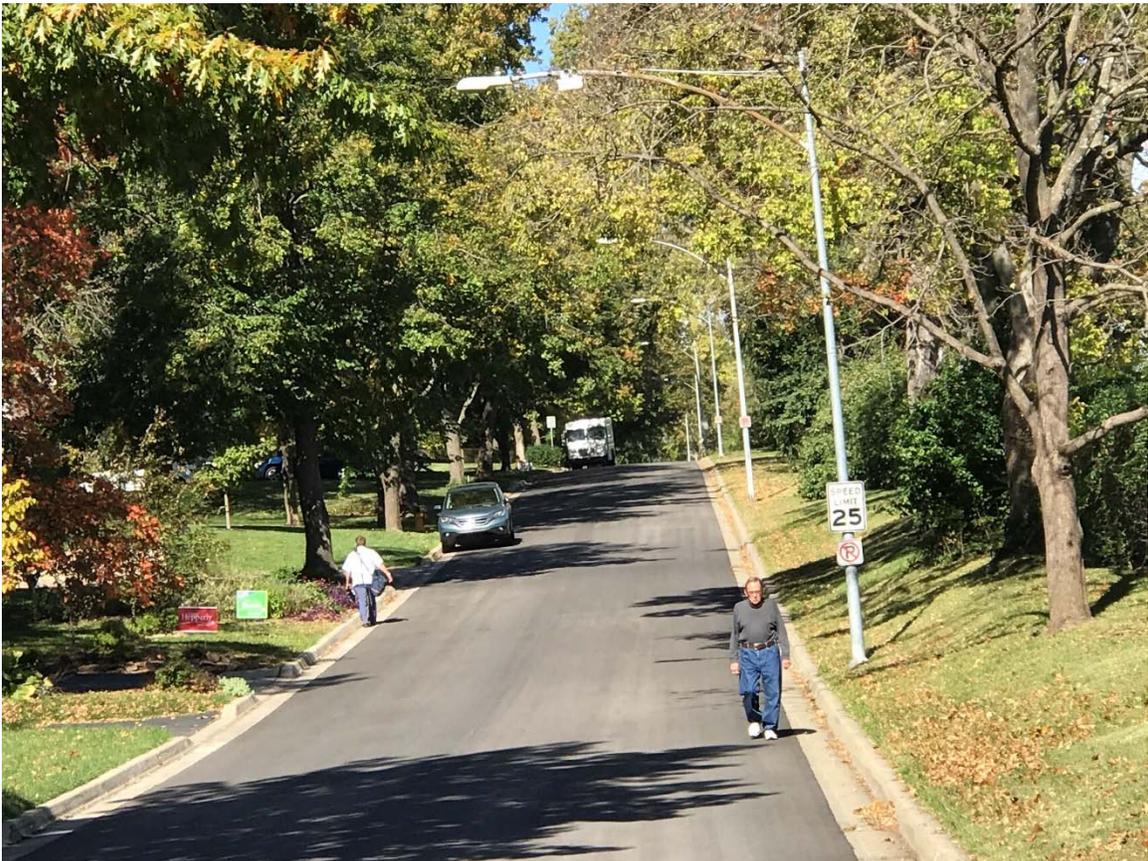
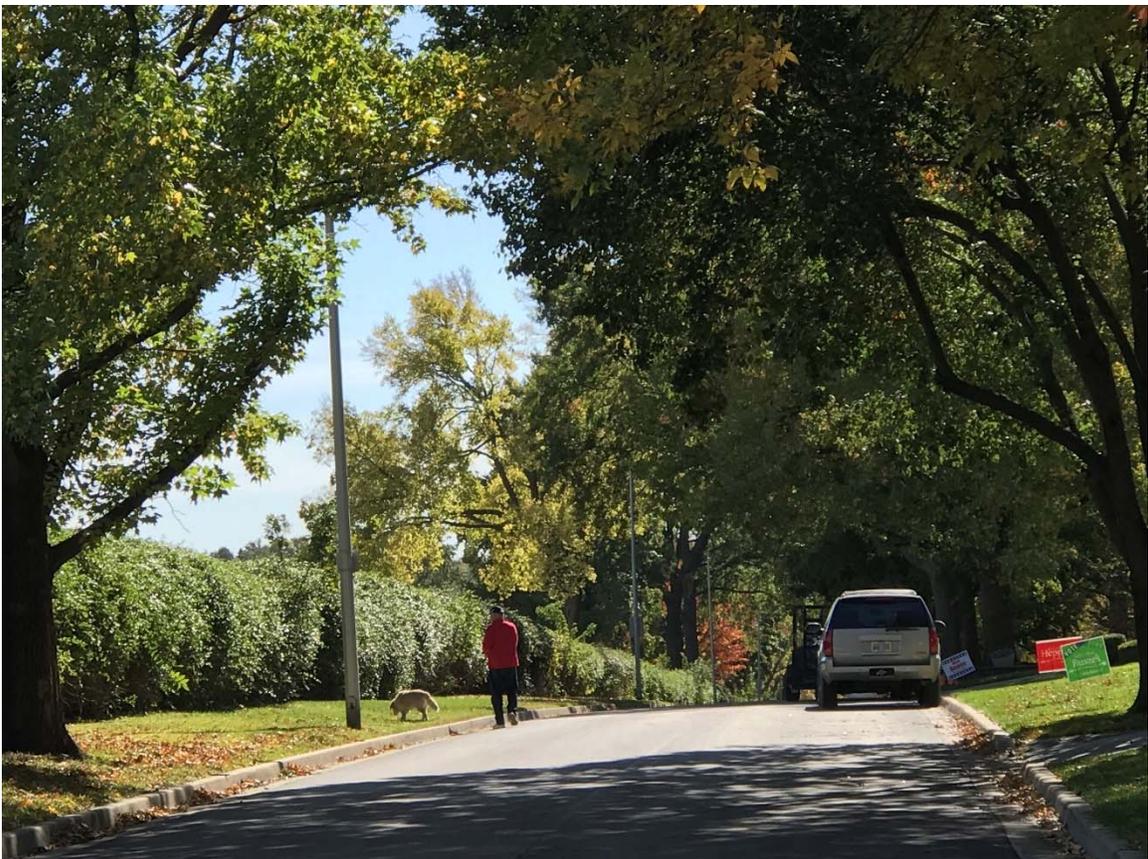
## EXHIBIT D

*Belinder Avenue – On-street Parking and Pedestrians Looking North*

*Belinder Avenue – On-Street Parking and Pedestrians Looking South*
